FARMINGTON RIVER BASIN
HARWINTON, CONNECTICUT

BRISTOL RESERVOIR NO.5 DAM
CT 00366

PHASE I INSPECTION REPORT
NATIONAL DAM INSPECTION PROGRAM

JULY 1980

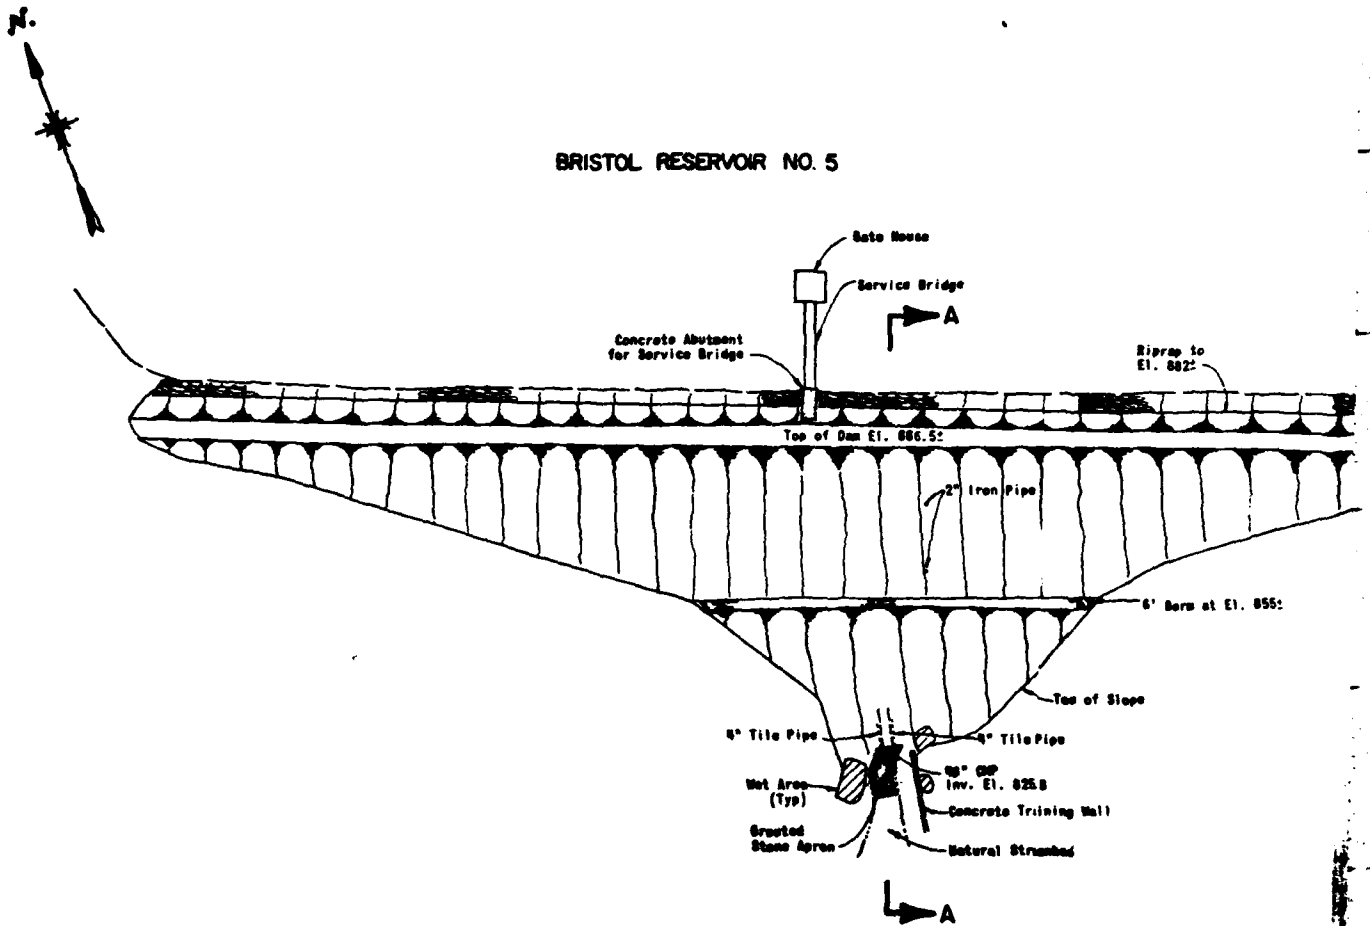
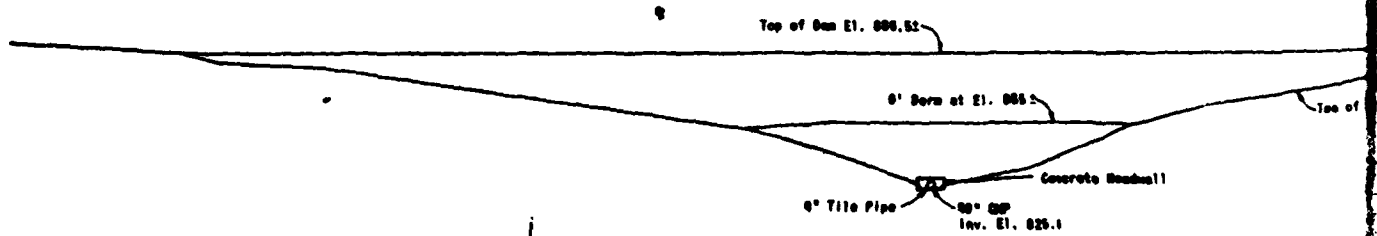
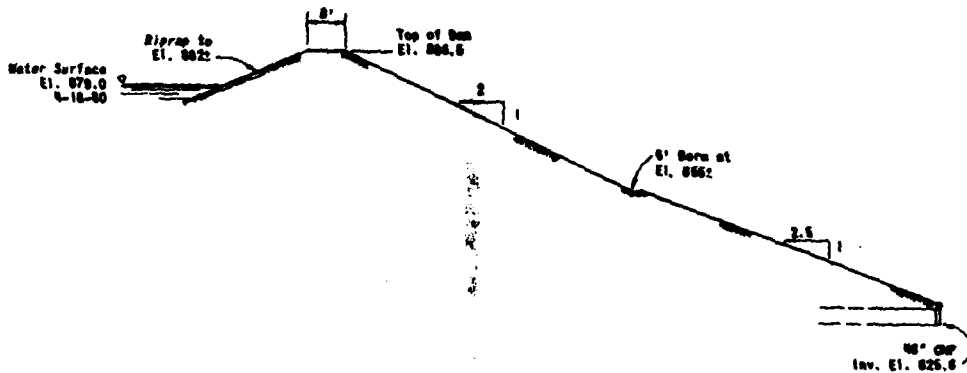
There are two 2-inch diameter iron pipes extending vertically from the downstream slope, see Figure 2A, page B-1 in Appendix B. The pipes appear to be observation wells and were reported to have been installed during the construction of the dam. The upper observation well could not be opened. The lower observation well was opened and a tape dropped down to the bottom, approximately 26.5 feet below ground surface. No water was present in the well.

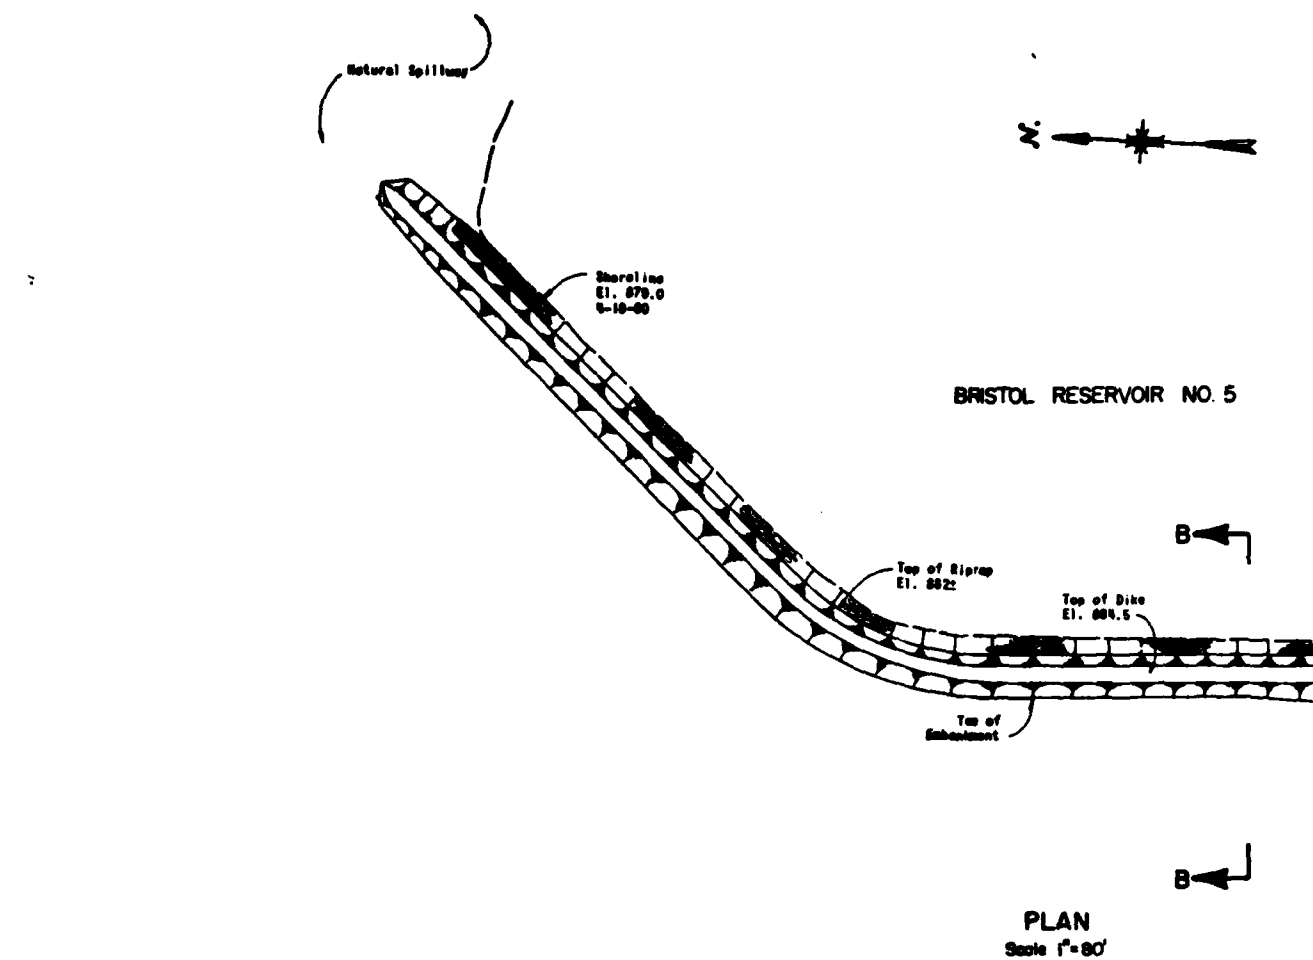
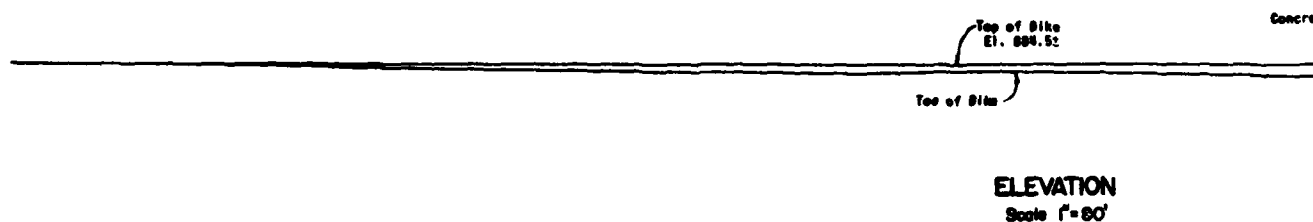
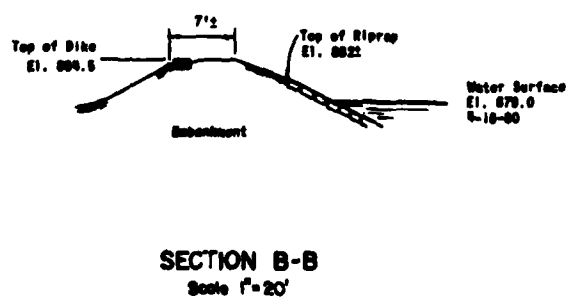
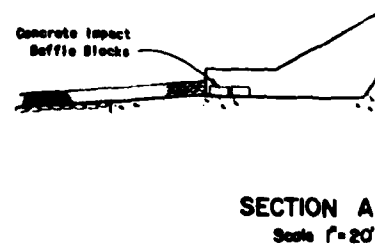
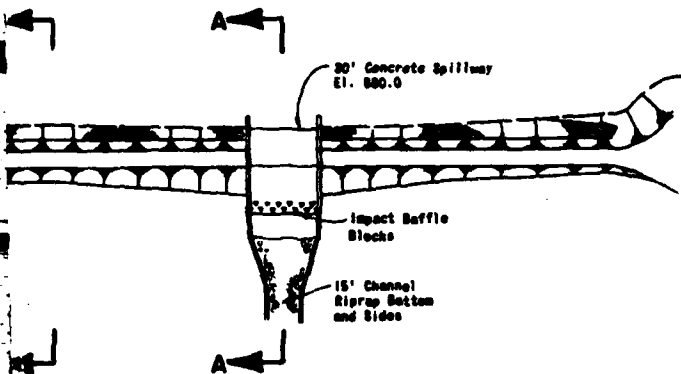
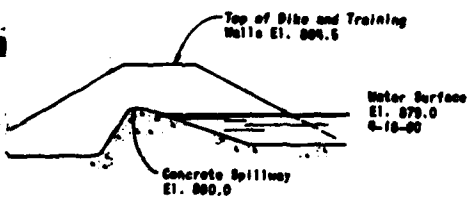
FIGURE 2B

Bristol Reservoir No. 5 is impounded by a main dam located on the south side of the reservoir and a dike located on the west side. The spillway is a 30 foot long concrete ogee section with a downstream concrete apron and concrete impact baffle blocks (See Figure 2B, page B-2). The spillway is located near the left end of the dike. There is a natural spillway approximately 120 feet in length consisting of a paved roadway and grassed area to the right of the dike. There is 4.5 feet of freeboard from spillway crest to the top of the dike. The top of the dike is approximately two feet lower than the top of the main dam and 0.5 feet higher than the natural spillway.
